Lifting Dharmadam Bridge

S.P. Pavithrasagar

Built in 1953, the third pier of Dharmadam Bridge, at 173/900km of National Highway 17, began sinking gradually after construction. This paper describes the lifting of the bridge and other repairs undertaken expeditiously, in order not to disrupt traffic inordinately.

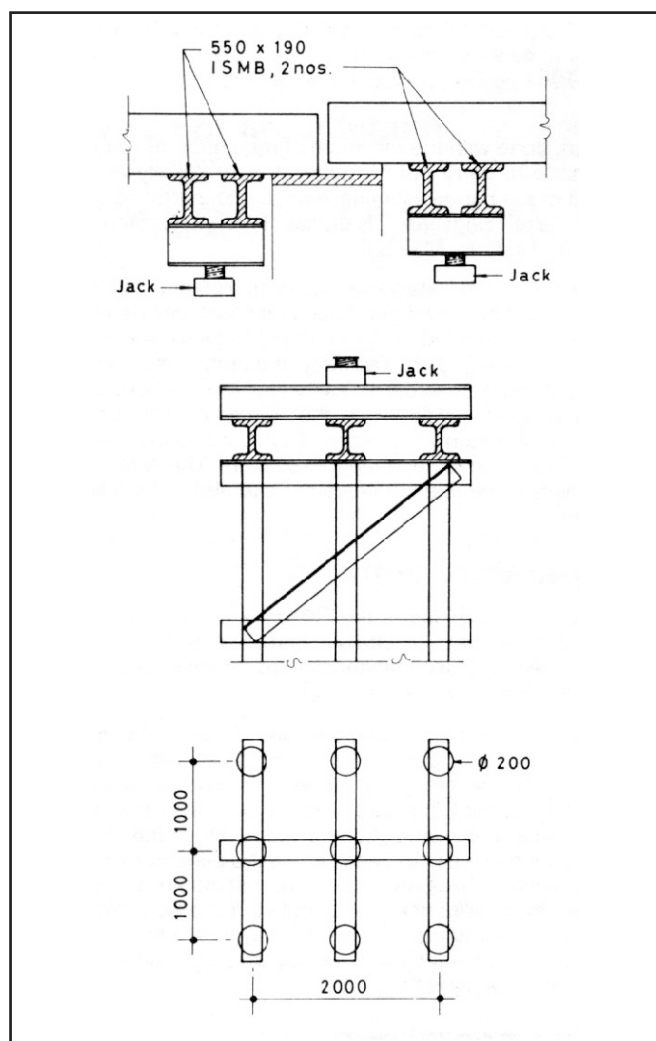
It was decided to have four sets of piles, each bunch totalling nine piles, Figures 1 and 2, three in a row, driven to refusal at the four corners of the pier outside the deck. Thus, a total of 36 teakwood piles of 200-mm diameter were driven to refusal. On a cluster of nine piles (three in a row, horizontal and three, perpendicular), the tops of three piles were connected at high-tide levels by placing steel rails so that the system could distribute the load uniformly, bracing the piles wherever

Figure 1. Lifting arrangements for piles and girders for Dharmadam Bridge

necessary. The rails were first placed horizontally and again at right angles, to form a cluster. Over this, sleepers were placed to rest the jack on and topped by two old mild steel girders, ISMB 550mm x 190mm, which were strengthened and tested to take the load of the three Tbeams and deck slabs running right across the span. The other ends of the girders were made to rest on the other side of the cluster of piles and on the jack. Thus, the girders were fixed on either side of the pier to lift the adjacent span.

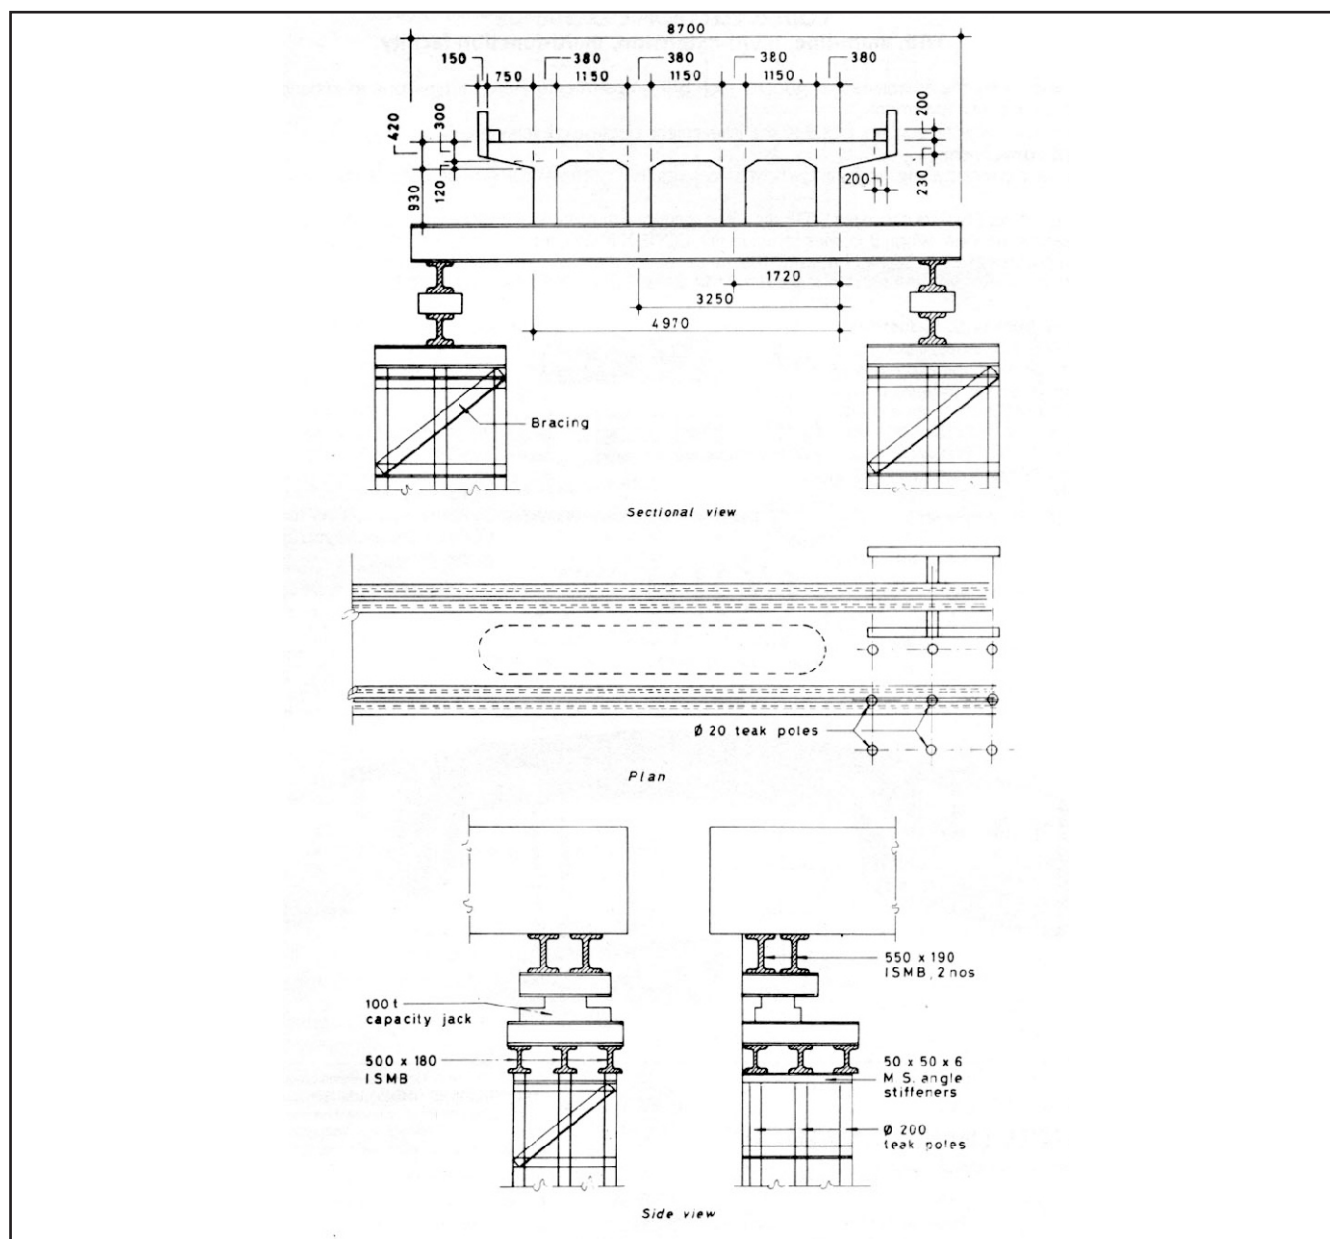
Figure 2. Views showing the lifting arrangements for Dharmadam Bridge. Four sets of piles, each totalling nine piles, three in a row, were used
